SITE INFORMATION

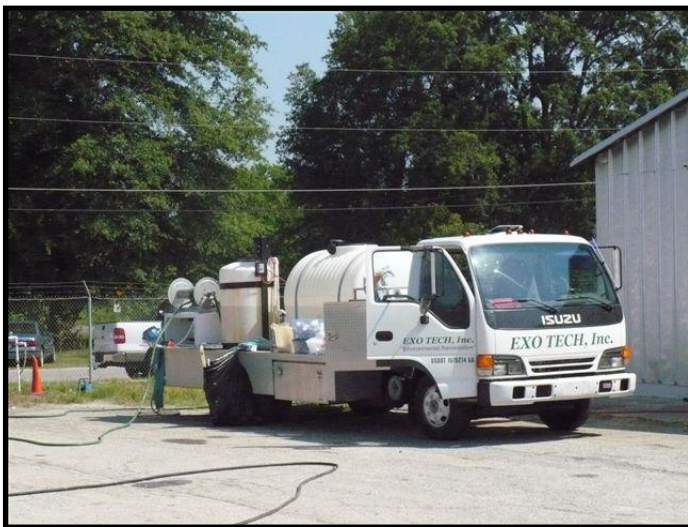
ExoTech Injection Truck

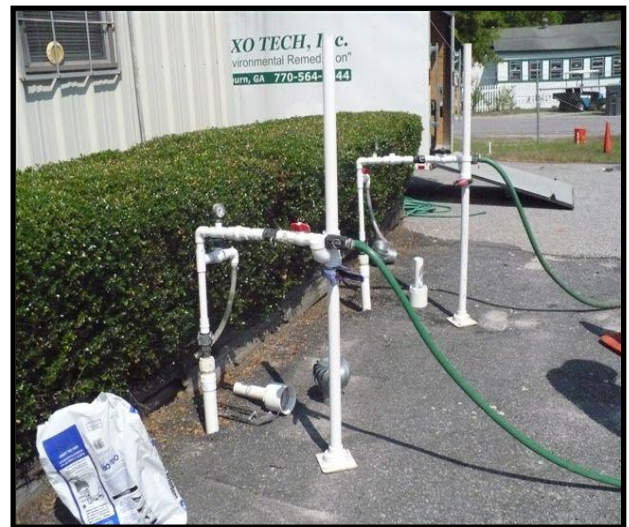
ISCO Injection (Sodium Persulfate)

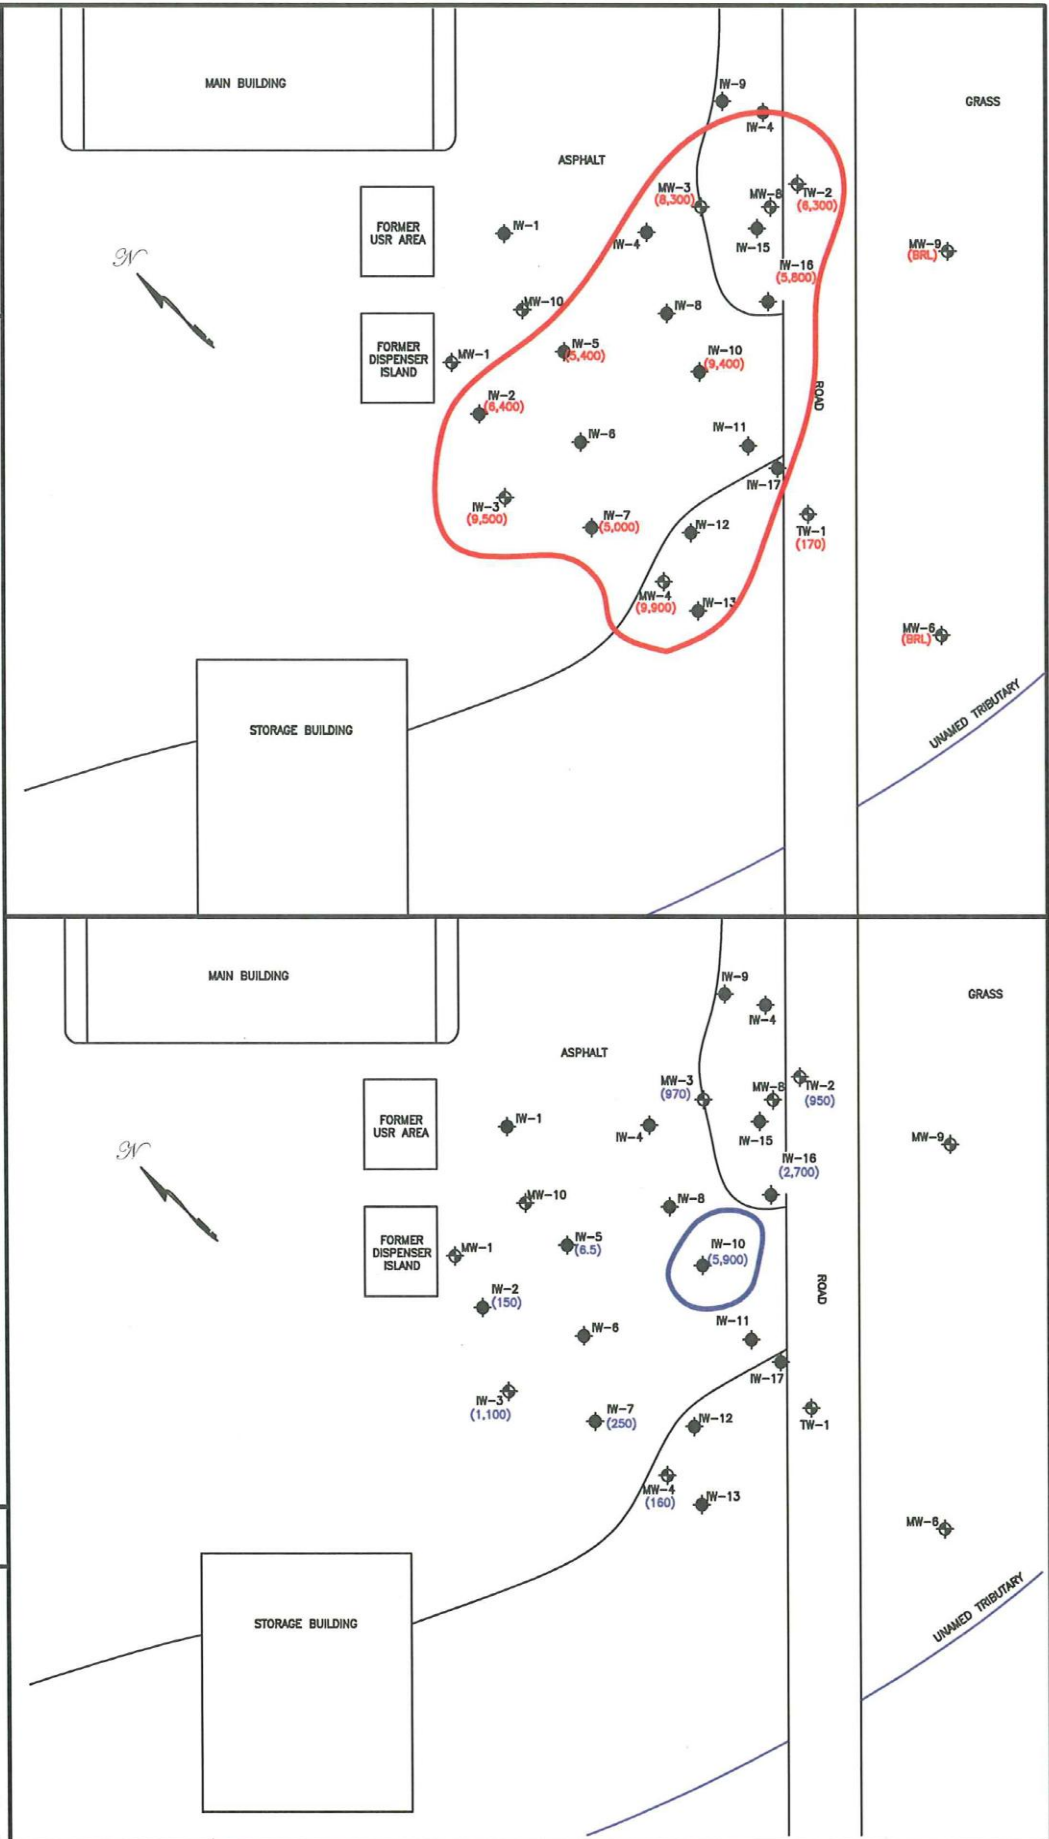
An active D.O.T. maintenance lot with a 3,300 square foot benzene plume was present due to a leaking under ground storage tank. After one injection performed by Exotech the plume was reduced to less than 150 square feet. No further action is pending.
